Galvanic Corrosion of Coated HY-130 Steel Coupled to 5456 Aluminum

NAVAL SHIP RESEARCH AND DEVELOPMENT CENTER

MATERIALS DEPARTMENT
Annapolis
RESEARCH AND DEVELOPMENT REPORT

March 1974

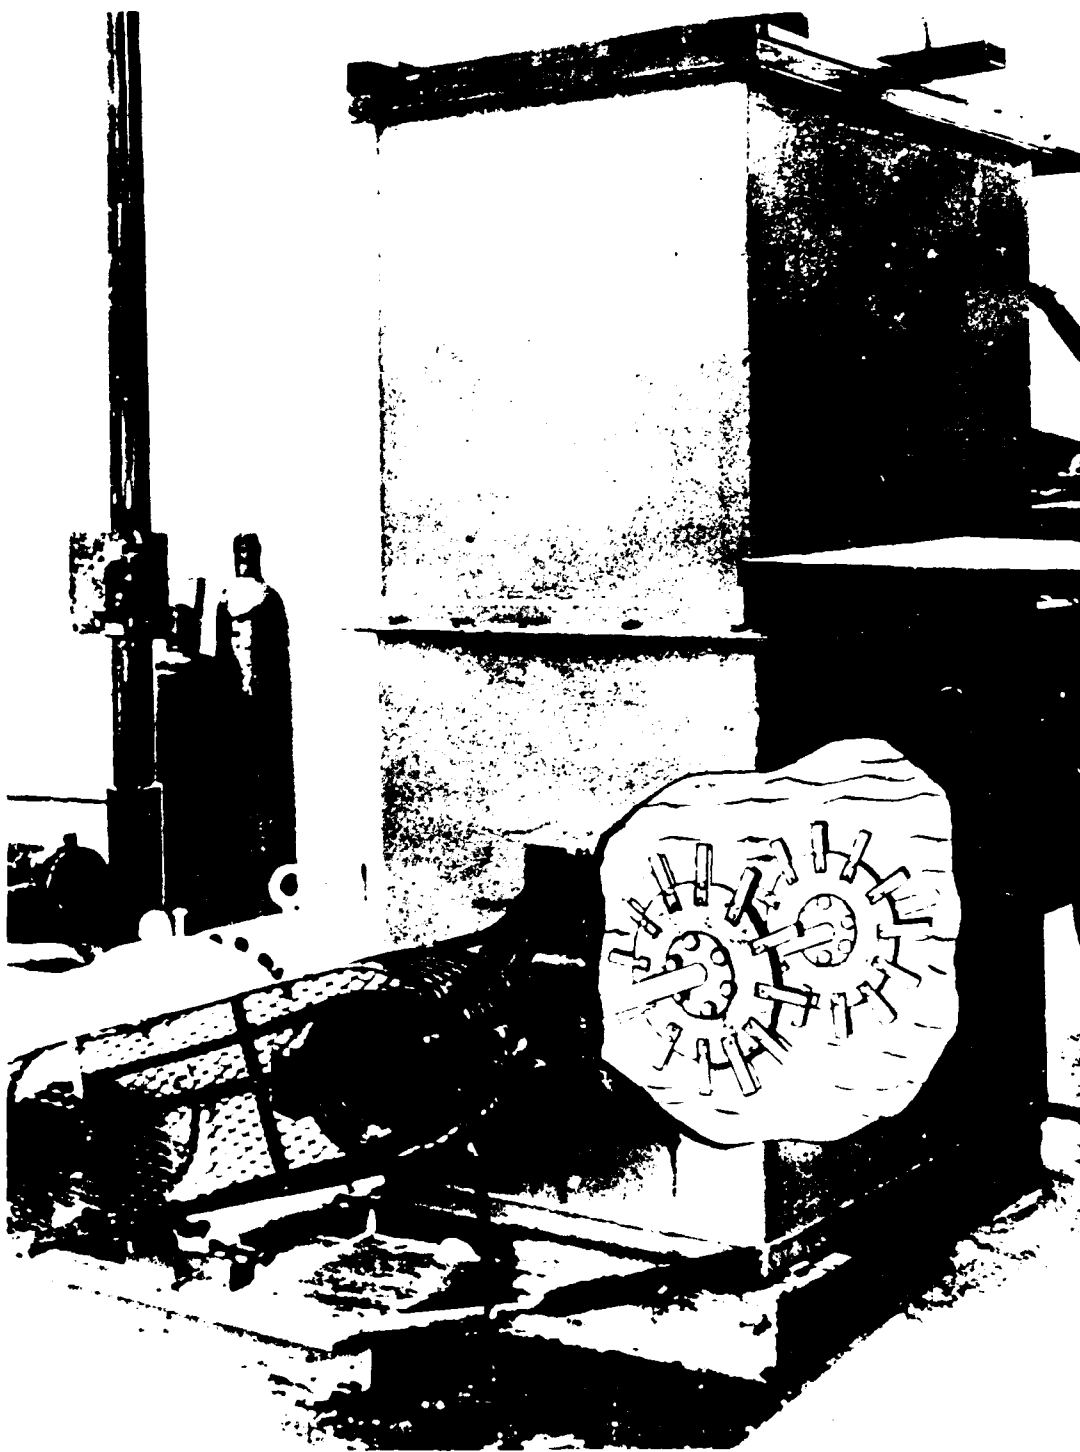
Figure 1
Rotating Disk Test Apparatus

Figure 1 illustrates the apparatus used in the tests; figure 2 shows the test specimens. Specimens were affixed to both sides of two micarta disks by means of common nylon or steel screws. The steel screws served as a means for galvanic coupling of the specimens as well as securing them to the disks. The disks were then mounted on a motor-driven rotating shaft

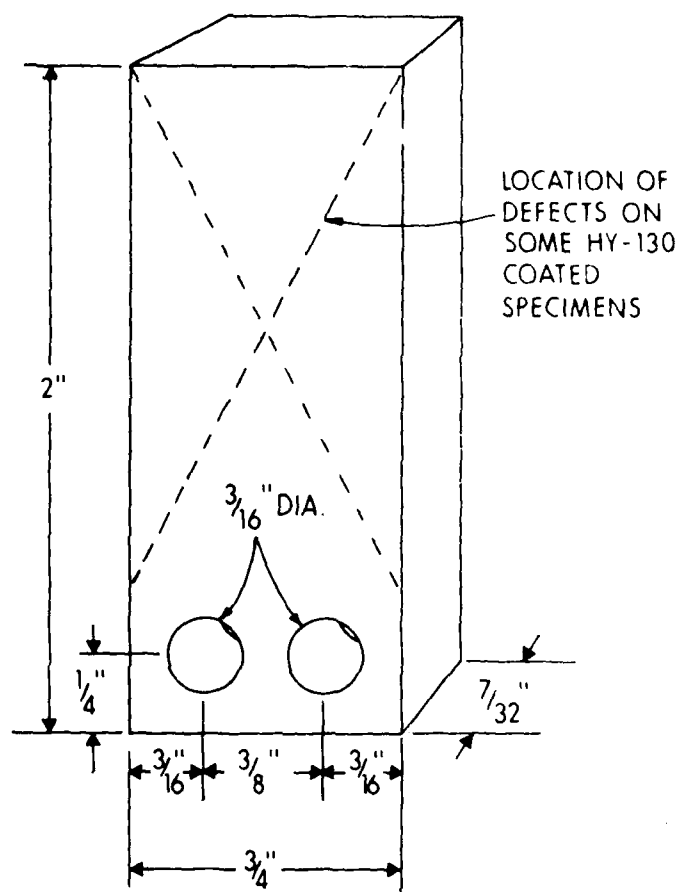
Figure 2
Rotating Disk Corrosion Test Specimen

All steel specimens except those reserved for adhesion measurements were sandblasted before coating. Coating coverage was varied to obtain specimens that were fully coated, coated with defect (knife-scribed X), 3/4 coated, and uncoated. The coating system used was an epoxy type, MIL-P-24441/1 primer and MIL-P-24441/2 topcoat. No aluminum specimens were sandblasted or coated.

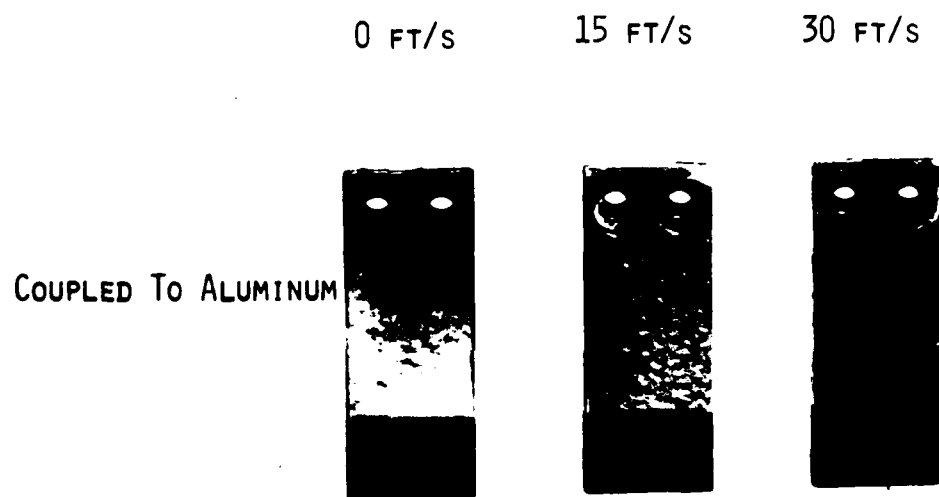
Figure 5
HY-130 Steel, Partially Coated
(No Specimens Tested in Uncoupled Condition)

Table 1 presents results of the exposures. Figures 3 through 6 show the visual evidence of the corrosion of the HY-130 specimens, while figures 7 through 9 show the degradation of the aluminum specimens. Weight-loss data is plotted for HY-130 in figure 10 and for aluminum in figure 11. From visual examination of the specimens and weight-loss data analysis, the following test results can be noted:

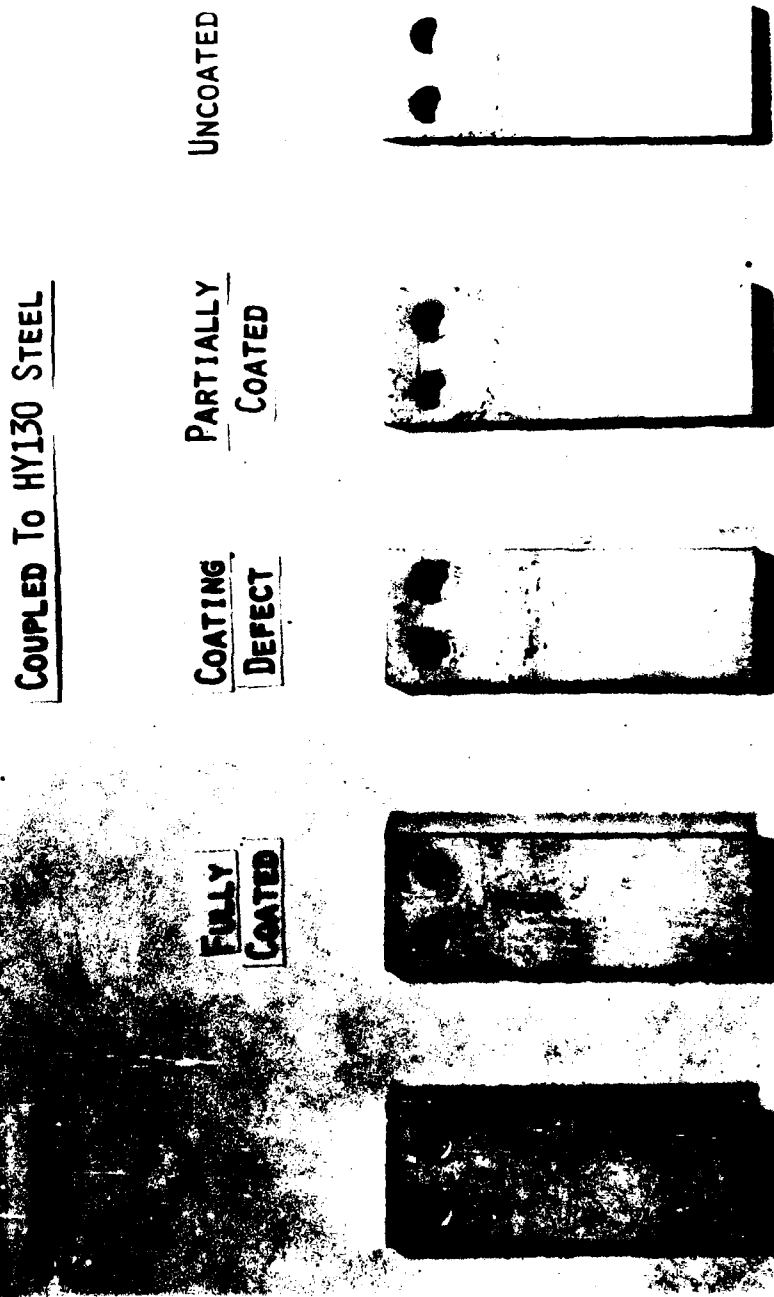
Figure 7
5456-H117 Aluminum, 0 FT/S

- The corrosion rate of the aluminum was increased from 2-30 times by coupling it to HY-130, with the effect increasing with increasing exposed areas of the steel. The corrosion rate of aluminum when coupled to steel at 30 ft/s can be described as catastrophic; while at 0 ft/s the effect can be considered moderate.

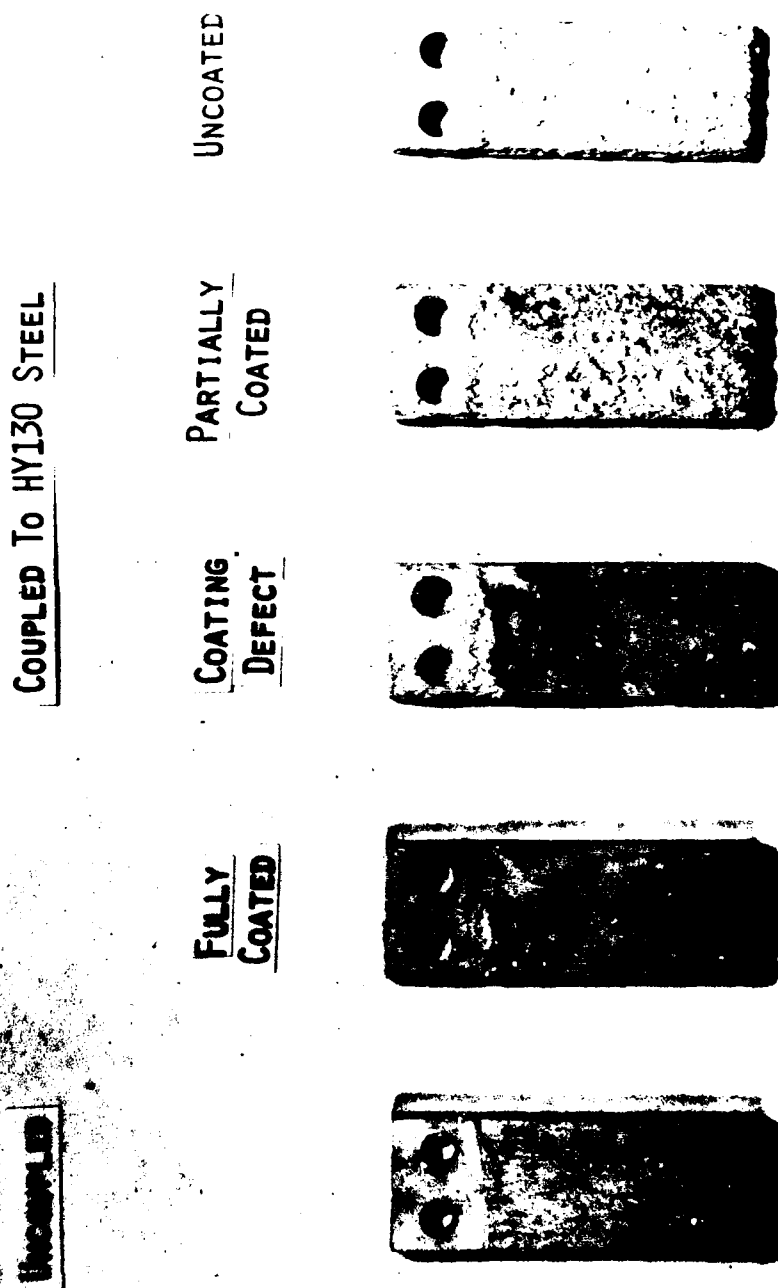
Figure 8
5456-H117 Aluminum, 15 FT/S

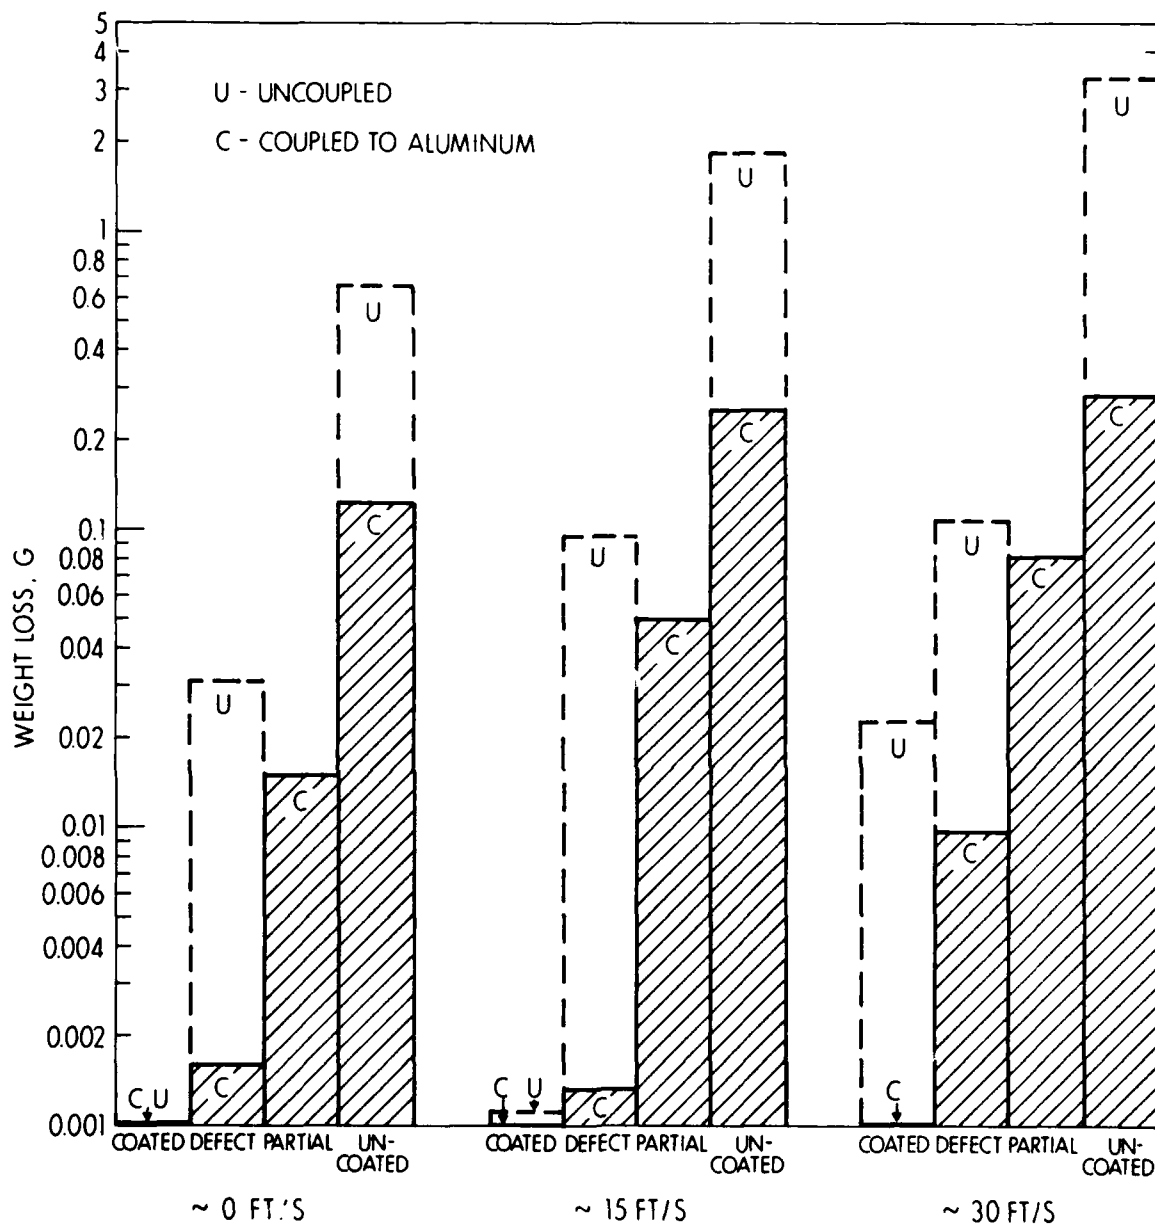
Figure 10
Corrosion of Coated HY-130

- Increasing the sea-water velocity increased the corrosion of the uncoated HY-130 by a factor of two when coupled to aluminum and a factor of five when uncoupled.
- Increasing the exposed area of HY-130 increased the overall weight loss roughly in proportion, indicating little corrosion of coated material.
- Coupling of HY-130 to aluminum decreased the amount of corrosion of the steel by 3-10 times, with the effect being greater at higher velocities.

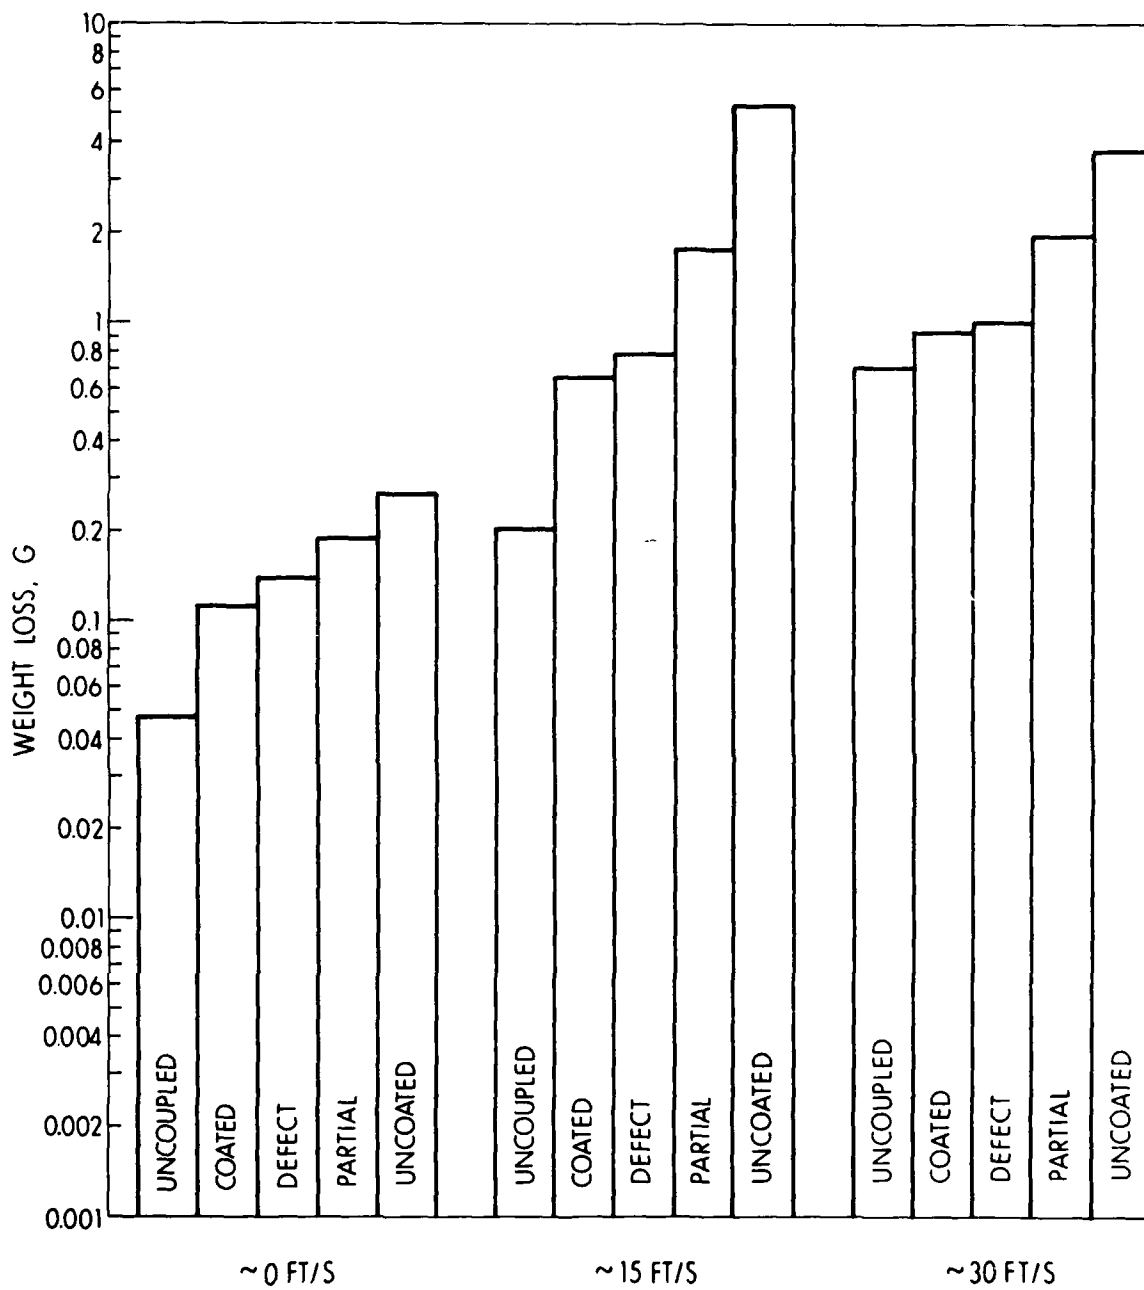
Figure 11
Corrosion of Aluminum Coupled to HY-130
